INDOOR AIR QUALITY ASSESSMENT

**Barnstable United Elementary School
730 Osterville W. Barnstable Road
Marstons Mills, Massachusetts**

Prepared by:
Massachusetts Department of Public Health
Bureau of Environmental Health
Indoor Air Quality Program
October 2019

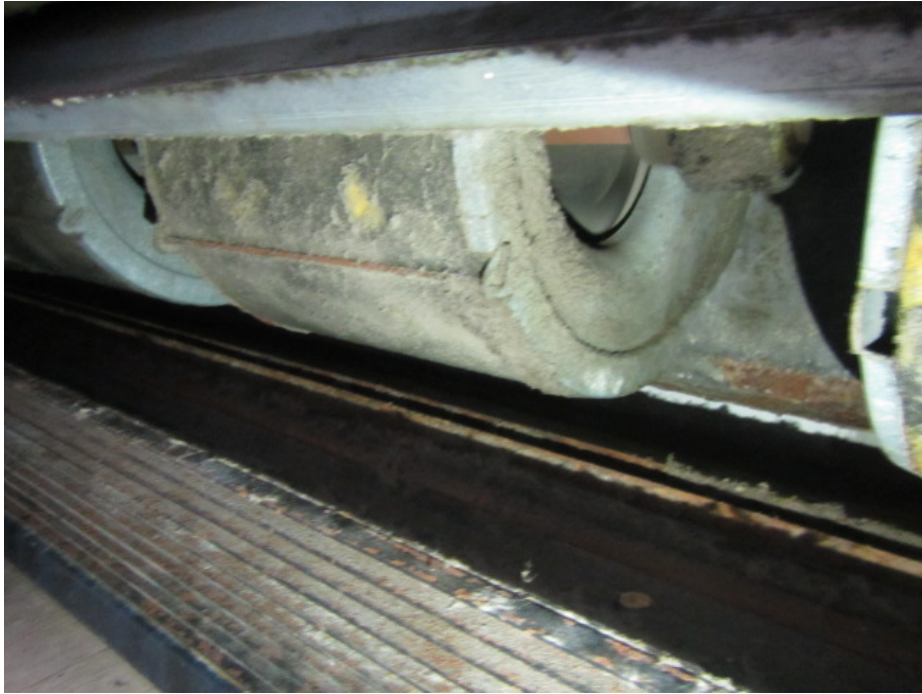
Picture 35

In some areas, exhaust vents, supply diffusers and the interior of univents had accumulated dust/debris (Table 1, Pictures 4, 34 and 35). This dust can be reaerosolized under certain conditions, and can also be a medium for mold growth. Univent cabinets can also accumulate dust and debris which should be cleaned when filters are changed (2-4 times/year).

Accumulated dust/debris on interior univent components

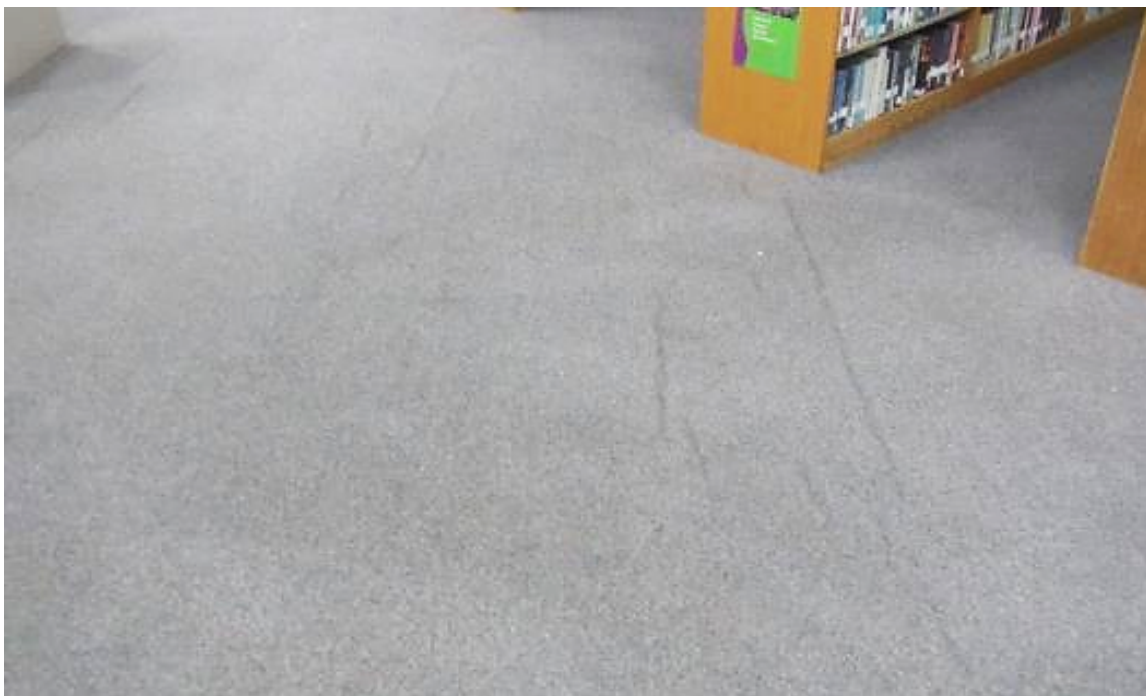
Picture 36

Some areas had wall to wall carpeting, in some cases the carpet was wrinkled/worn and appeared to be past its useful life (Pictures 36 and 37). The service life of carpeting in schools is approximately 10-11 years (IICRC, 2002). Aging carpet can produce fibers that can be irritating to the respiratory system. In addition, tears or lifting carpet can create tripping hazards. Area rugs were also observed in many classrooms (Table 1). Carpets should be cleaned annually (or semi-annually in soiled/high traffic areas) in accordance with Institute of Inspection, Cleaning and Restoration Certification (IICRC) recommendations, (IICRC, 2012). Regular cleaning with a high efficiency particulate air (HEPA) filtered vacuum in combination with an annual cleaning will help to reduce accumulation and potential aerosolization of materials from carpeting. Area carpets too worn to be effectively cleaned should be replaced. Area rugs should be rolled up and stored in a clean, dry place when rooms are not occupied during the summer months to prevent moistening due to condensation.

Original (20+ yr.)/wrinkled carpeting in Library

32. Consider a long-term plan to replace all carpeting in the building as funds become available. Consider replacing carpeting with a non-porous surface such as vinyl tile particularly in below-grade areas.

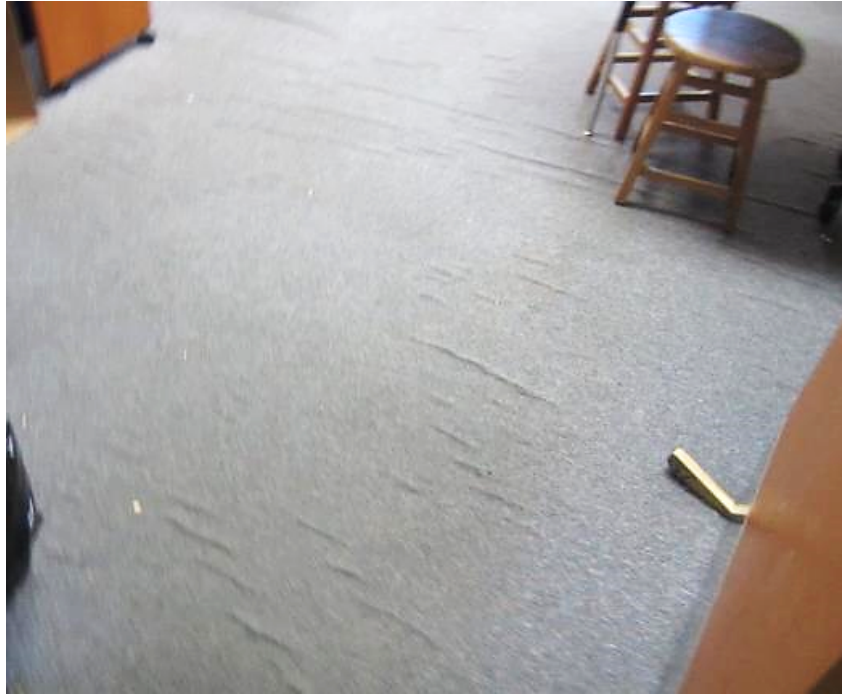
Picture 37

Original (20+ yr.)/wrinkled carpeting in Guidance Dept

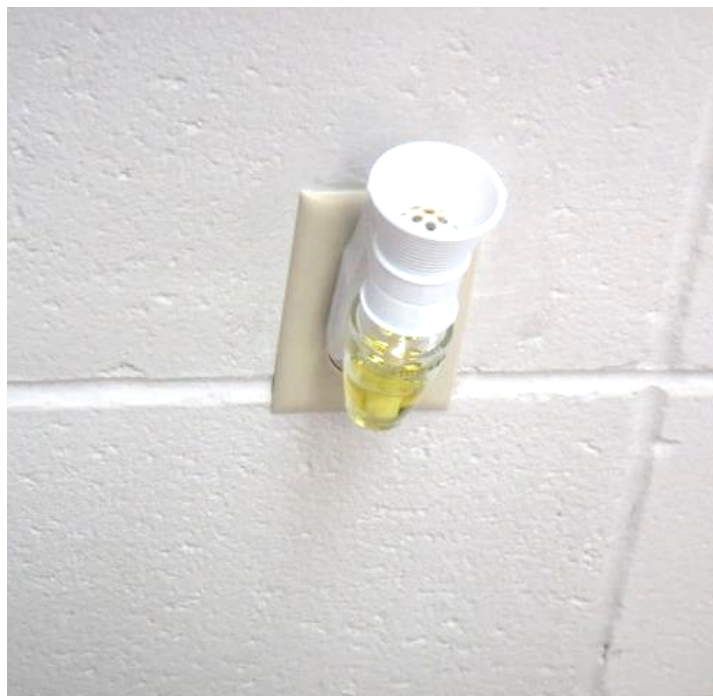
Picture 38

Plug-in air freshener in classroom
